**Flood Control Project Maintenance
Levee Inspections**

Maintenance Issue Types Only, Levee Inspection Report By Mile - Spring 2019

Reclamation District No. 0150 Merrit Island

Waterway	Bank	Unit Miles	Inspection Start/End	Inspector
Unit No. 01 Sutter Slough	Left	0.52	04/12/2019 04/12/2019	Luz Dial

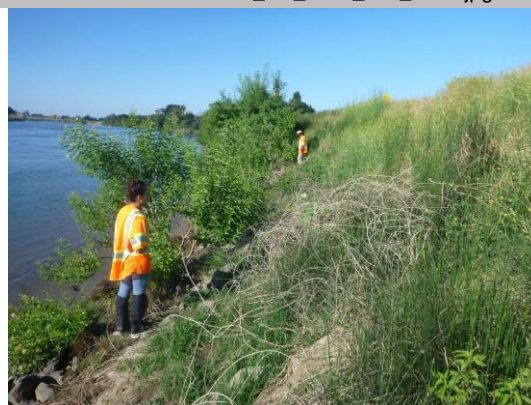
Photo 1 of 3 : LEVAL_SP_2019_286_1942.jpg

LM Start	0.11	Rating **	A/W	Issue No.	46
LM End	0.14	Issue Type +	Ma	Location *	WS
Category	Supplemental			GPS Latitude/Longitude	
				Start	End
Item	2017 Storm Damage			38.329369 °	38.329767 °
				-121.574936 °	-121.574589 °
DWR ID	DWR_RD0150_02_f _ 2017_46				
Comment Code					
Inspector Comment					
Levee Evaluation Comments					
Description: The flood damage consists of a waterside erosion approximately 185 feet long on the west (right) bank of the Sacramento River. See attached pages for photos.					
Site ID No:286					
Site Designation:LMA-112					
Repair Type: Erosion					
Rating: Area of Concern					
Field Date:7/17/2017					
Notes: Crown is a paved road. Scarps up to 3 ft deep, not fully vertical though. Area of concern because erosion is not very deep into prism.					
2019 Spring DWR Inspection: Erosion was not visible due to high water.

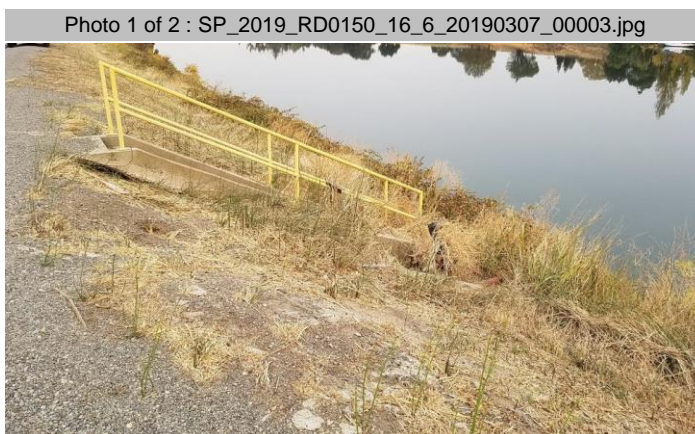
LM Start	0.38	Rating **	M	Issue No.	6
LM End	0.38	Issue Type +	Ma	Location *	WS
Category	Earthen Levee			GPS Latitude/Longitude	
				Start	End
Item	Slope Stability			38.332598 °	38.332598 °
				-121.572179 °	-121.572179 °
DWR ID	DWR_RD0150_02_s_2012_6				
Comment Code					
S2 : Repair the levee slope damaged by foot traffic and prevent access where possible.					
Inspector Comment

View of slope instability around stairway. Fall 2018

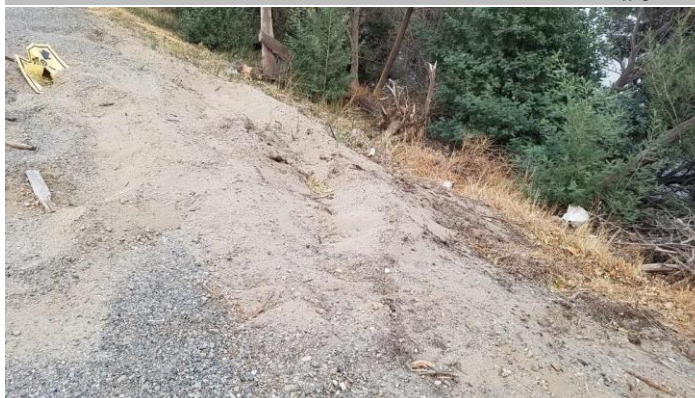
Photo 1 of 1 : SP_2019_RD0150_16_45_20190307_00018.jpg

LM Start	0.59	Rating **	M	Issue No.	45
LM End	0.59	Issue Type +	Ma	Location *	WS
Category	Earthen Levee			GPS Latitude/Longitude	
				Start	End
Item	Slope Stability			38.334898 °	38.334898 °
				-121.569632 °	-121.569632 °
DWR ID	DWR_RD0150_02_f_2018_45				
Comment Code					
S3 : Repair the levee slope damaged by vehicle traffic and prevent access where possible.					
Inspector Comment

View of slope damage likely from vehicle traffic. Fall 2018

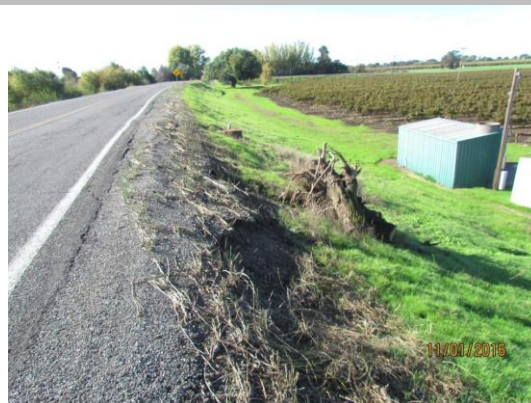
Photo 2 of 2 : SP_2019_RD0150_16_59_20190307_00042.jpg

LM Start	0.71	Rating **	U	Issue No.	59
LM End	0.71	Issue Type +	Ma	Location *	LS
Category	Earthen Levee			GPS Latitude/Longitude	
				Start	End
Item	Trim / Thin Trees			38.336291 °	38.336291 °
				-121.568260 °	-121.568260 °
DWR ID	DWR_RD0150_02_s_2016_59				
Comment Code					
T5 : Tree stumps.					
Inspector Comment					
Damaged tree roots and trunks appear to damage landside slope of the levee and need to be removed.

View of the tree limbs and roots on the landside of the levee looking downstream. Fall 2016

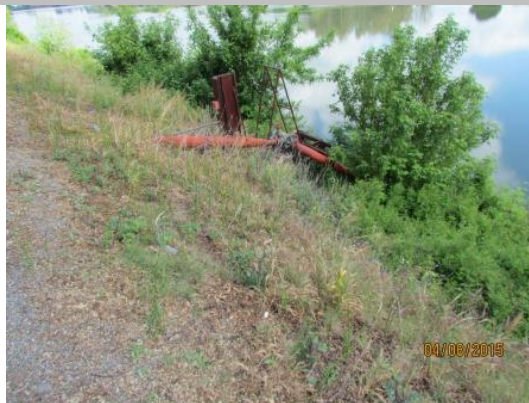
Photo 1 of 5 : SP_2019_RD0150_16_961_20190307_00066.jpg

LM Start	3.24	Rating **	M	Issue No.	961
LM End	3.24	Issue Type +	Ma	Location *	WS
Category	Earthen Levee			GPS Latitude/Longitude	
				Start	End
Item	Erosion / Bank Caving			38.355321 °	38.355321 °
				-121.530902 °	-121.530902 °
DWR ID	DWR_RD0150_02_s_2012_961				
Comment Code					
E2 : Schedule repair of erosion site prior to the next inspection.					
Inspector Comment					
Depressions into the waterward slope can be seen along the waterward slope at this site. Also note the damaged pump support, pump, and pipe just upstream of the site; they may contribute to the erosion in a high water event and should be removed.

View of the erosion on the waterside of the levee during spring 2015 inspection.

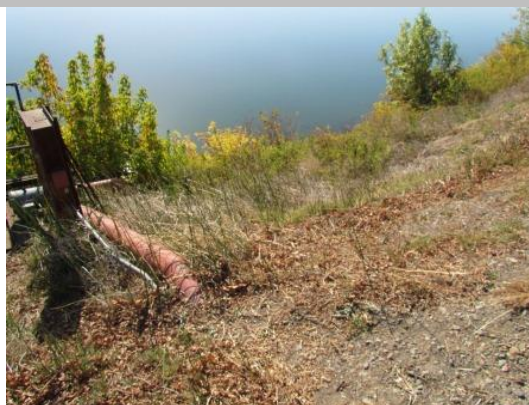
Photo 2 of 5 : SP_2019_RD0150_16_961_20190307_00067.jpg

View of the erosion on the waterside slope of the levee near the pipe looking downstream. This picture was taken during the fall 2013 inspection.

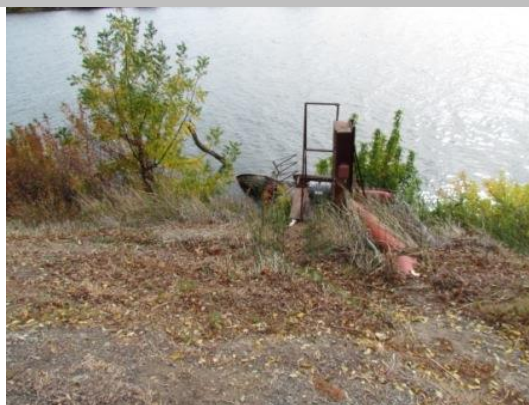
Photo 4 of 5 : SP_2019_RD0150_16_961_20190307_00069.jpg

View of erosion and damaged pipe and abandoned boat on the waterside of the levee looking upstream. This picture was taken during fall 2012 inspection.

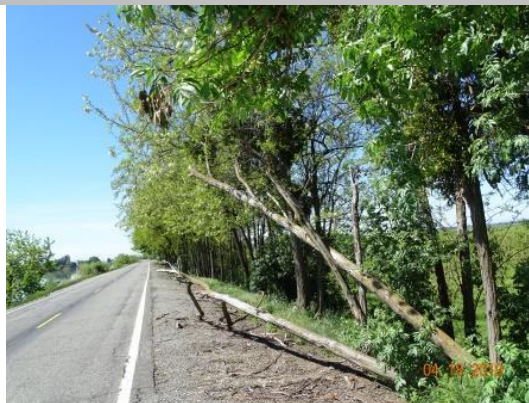
Photo 1 of 1 : SP_2019_RD0150_16_89_20190422_00130.jpg

View of fallen tree on levee slope. Spring 2019

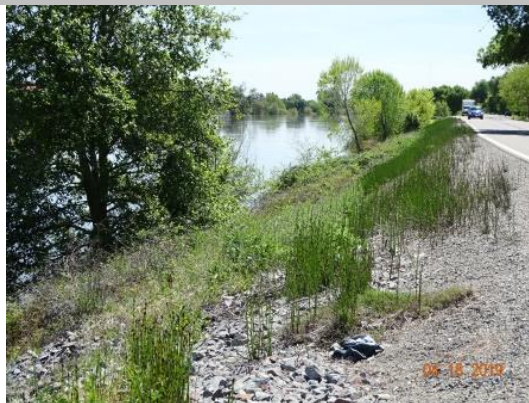
Photo 1 of 1 : SP_2019_RD0150_16_38_20190422_00132.jpg

View looking downstream at 2017 USACE Erosion Survey site. Spring 2019

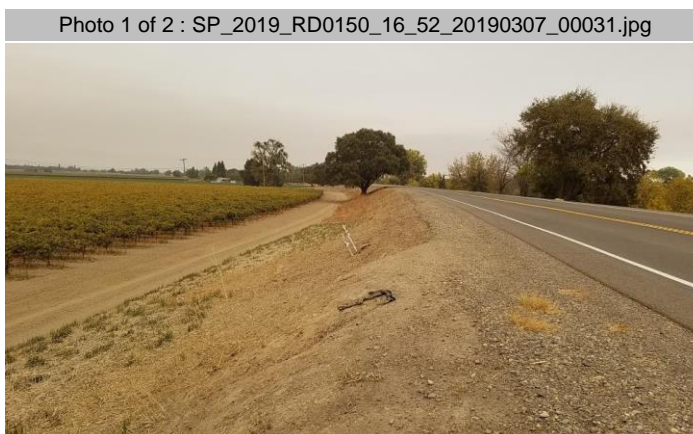
LM Start	5.90	Rating **	M	Issue No.	52
LM End	5.90	Issue Type +	Ma	Location *	LS
Category	Earthen Levee			GPS Latitude/Longitude	
				Start	End
Item	Erosion / Bank Caving			38.387915 °	38.387915 °
				-121.516002 °	-121.516002 °
DWR ID	DWR_RD0150_02_f_2016_52				
Comment Code					
E2 : Schedule repair of erosion site prior to the next inspection.					
Inspector Comment					
Repair erosion due to runoff.

View of erosion due to runoff. Fall 2018

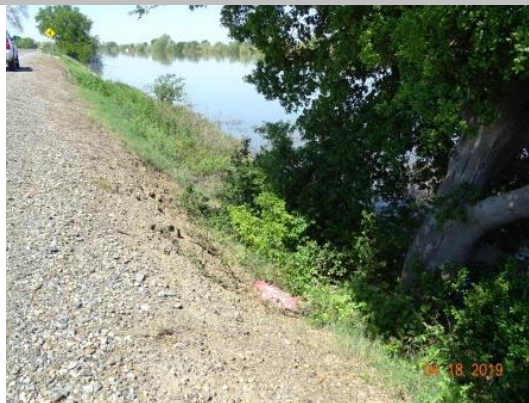
Photo 1 of 5 : SP_2019_RD0150_16_53_20190422_00133.jpg

View looking upstream at erosion around tree. Spring 2019

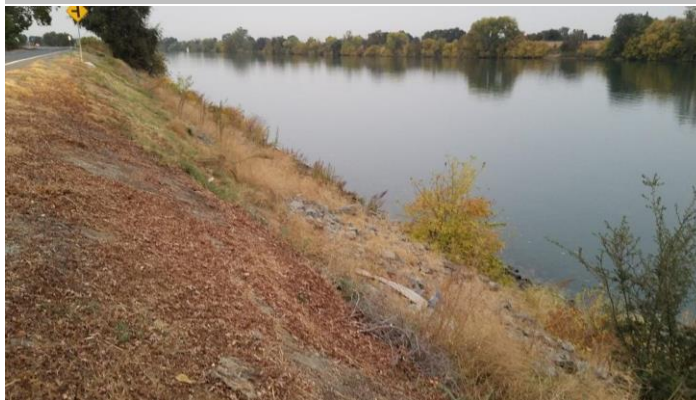
Photo 2 of 5 : SP_2019_RD0150_16_53_20190307_00033.jpg

View of waterside slope with some revetment. Fall 2018

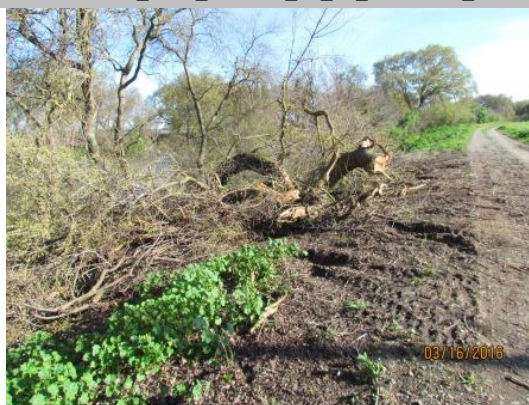
Photo 1 of 1 : SP_2019_RD0150_17_85_20190307_00070.jpg

View of broken tree trunk on the waterside slope of the levee. Spring 2016

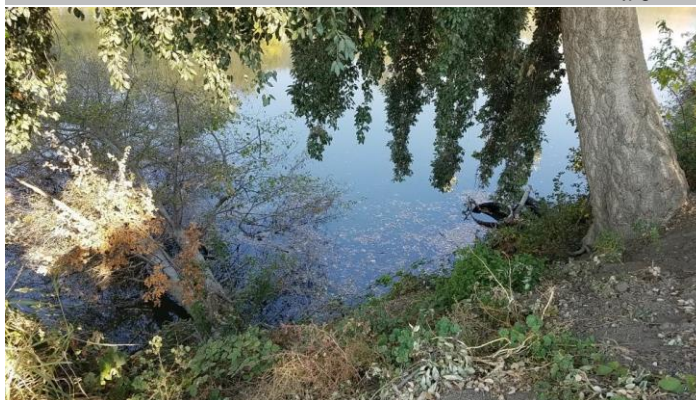
Photo 1 of 4 : SP_2019_RD0150_17_37_20190307_00019.jpg

View of slope damage near fallen tree. Fall 2018

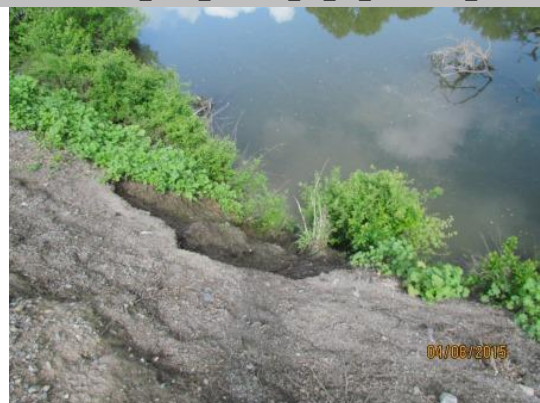
Photo 1 of 2 : SP_2019_RD0150_17_40_20190307_00024.jpg

View of erosion on the waterside of the levee during spring 2015 inspection.

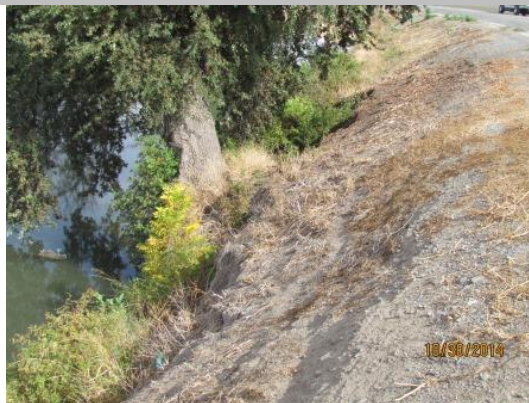
Photo 2 of 2 : SP_2019_RD0150_17_40_20190307_00025.jpg

View of erosion on the waterside of the levee looking upstream during fall 2014 inspection.

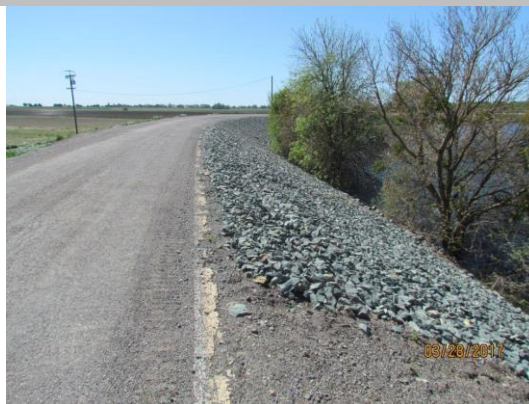
Photo 1 of 1 : SP_2019_RD0150_17_76_20190307_00064.jpg

View of the new riprap on the waterside slope of the levee looking downstream. Spring 2017

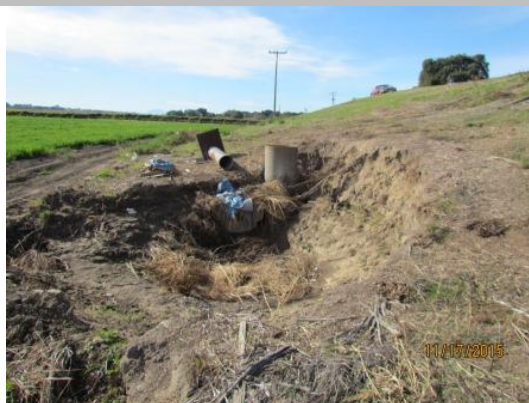
Photo 2 of 3 : SP_2019_RD0150_17_115_20190307_00102.jpg

View of the ditch on the landside toe of the levee during fall 2015 inspection.

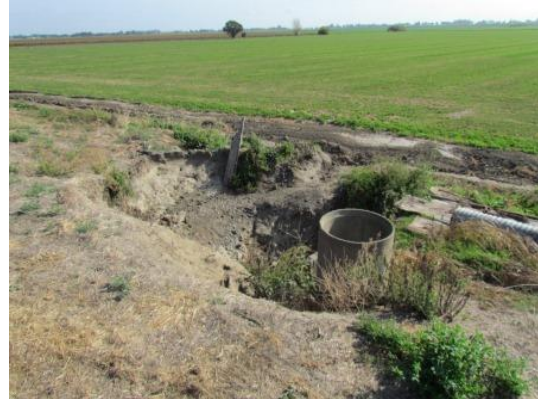
Photo 3 of 3 : SP_2019_RD0150_17_115_20190307_00103.jpg

A drainage ditch with depth of 4 feet and width of 15 feet was found on the landside toe of the levee. The picture was taken from the landside slope looking upstream during the fall 2013 inspection.

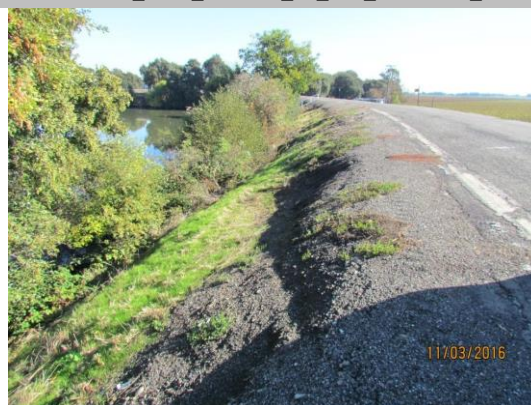
Photo 1 of 1 : SP_2019_RD0150_17_116_20190307_00104.jpg

View of slope instability on the waterside of the levee. Fall 2016

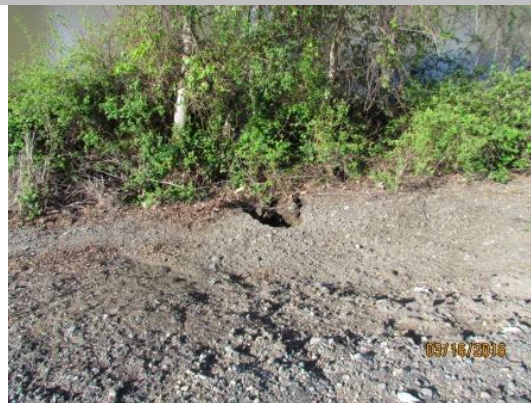
Photo 1 of 1 : SP_2019_RD0150_17_93_20190307_00079.jpg

Erosion was found on the waterside toe of the levee. Spring 2016

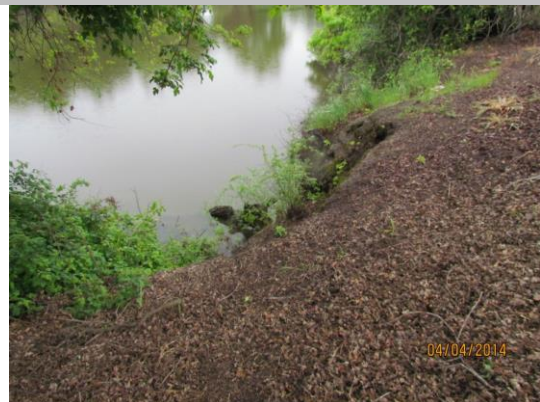
Photo 1 of 1 : SP_2019_RD0150_17_80_20190307_00065.jpg

LM Start	4.49	Rating **	A/W	Issue No.	80
LM End	4.49	Issue Type +	Ma	Location *	WS
Category	Earthen Levee			GPS Latitude/Longitude	
				Start	End
Item	Erosion / Bank Caving			38.374355 °	38.374355 °
				-121.547436 °	-121.547436 °
DWR ID	DWR_RD0150_03_s_2014_80				
Comment Code					
E1 : Note and monitor erosion site.					
Inspector Comment

View of an erosion site on the waterside toe of the levee looking upstream. Spring 2014

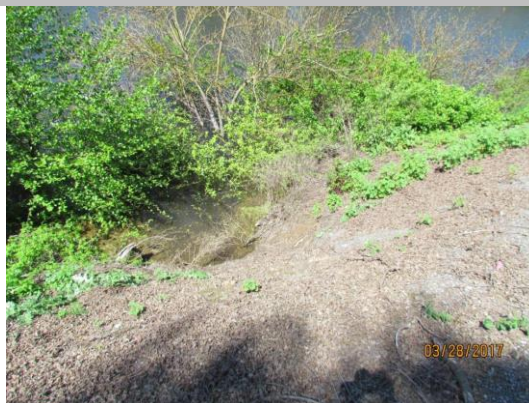
Photo 1 of 1 : SP_2019_RD0150_17_101_20190307_00088.jpg

View of an erosion on the waterside toe of the levee. Spring 2017

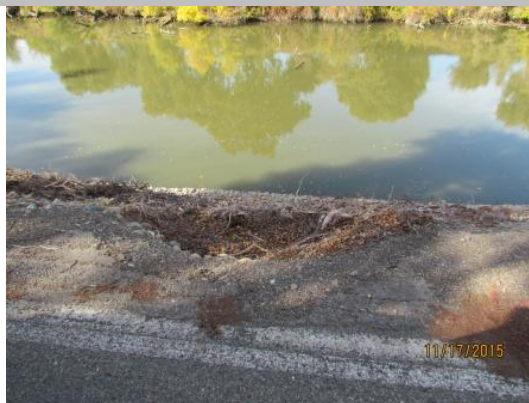
Photo 1 of 2 : SP_2019_RD0150_17_36_20190307_00017.jpg

View of slope instability on the waterside shoulder of the levee during fall 2015 inspection.

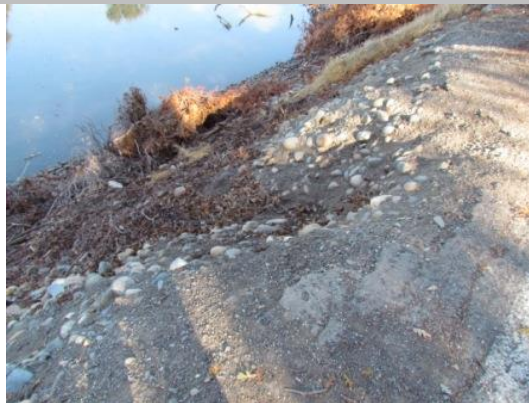
Photo 2 of 2 : SP_2019_RD0150_17_36_20190307_00018.jpg

Slope instability was found on the waterside of the levee looking upstream.

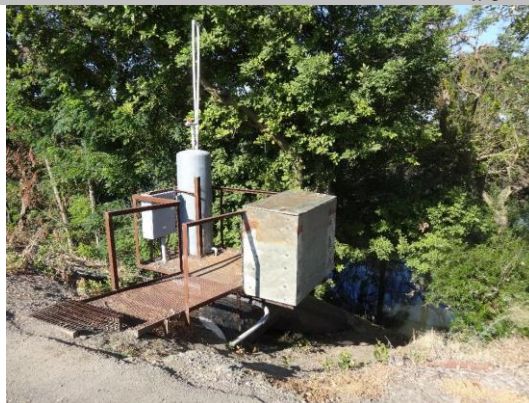
Photo 1 of 3 : UCIP_SP_2019_49386_63902.jpg

WS view: pipe, steel deck, pressure tank, electric control box on stream bank.

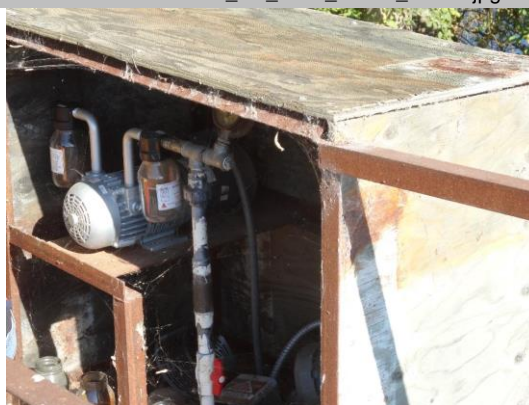
Photo 2 of 3 : UCIP_SP_2019_49386_63901.jpg

WS view: a smaller pump on steel deck. It was working during the survey.

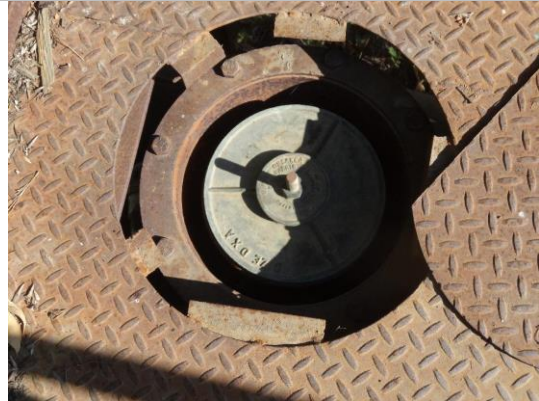
WS view: siphon breaker on pipe in steel deck on stream bank.

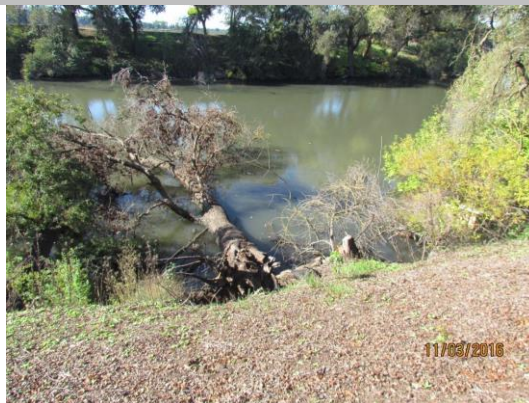
View of tree stump and broken tree on the waterside toe of the levee.
Fall 2016

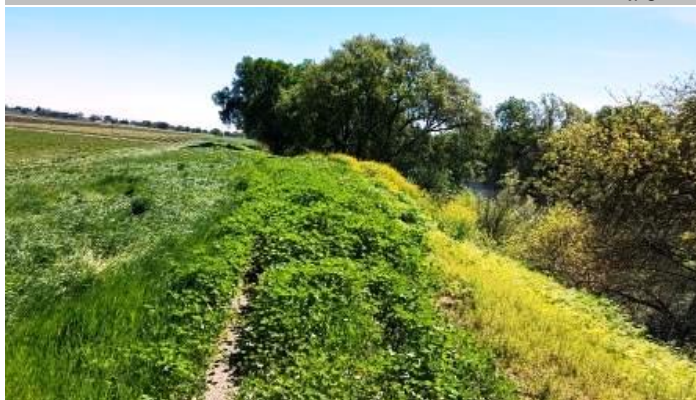
View of tall vegetation on levee crown. Spring 2019

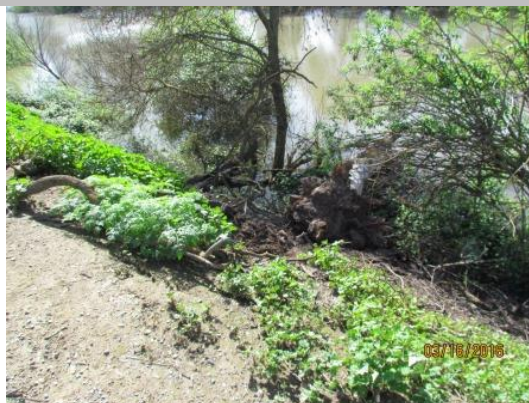
Broken tree roots and tree trunks were found on the waterside toe of the levee. Spring 2016

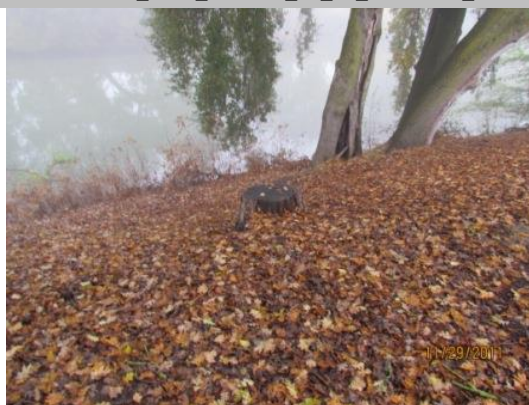
Tree stump was found on the waterside of the levee looking upstream.
Fall 2011

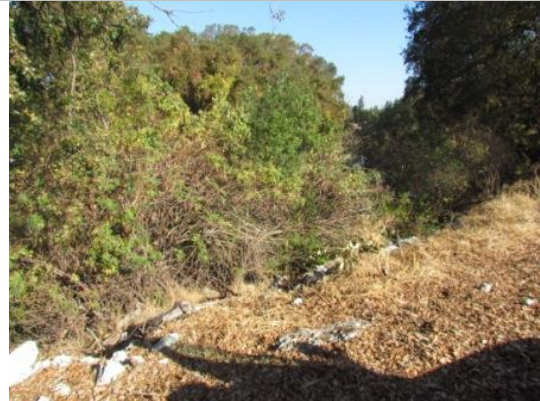
Wild growth was found on the waterside slope of the levee looking upstream.

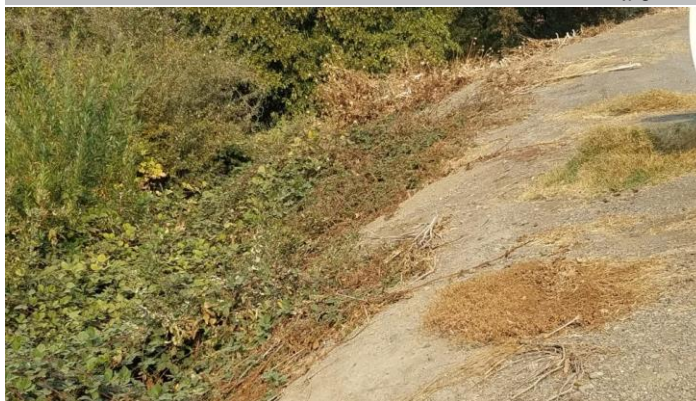
View of wild growth within levee easement. Fall 2018

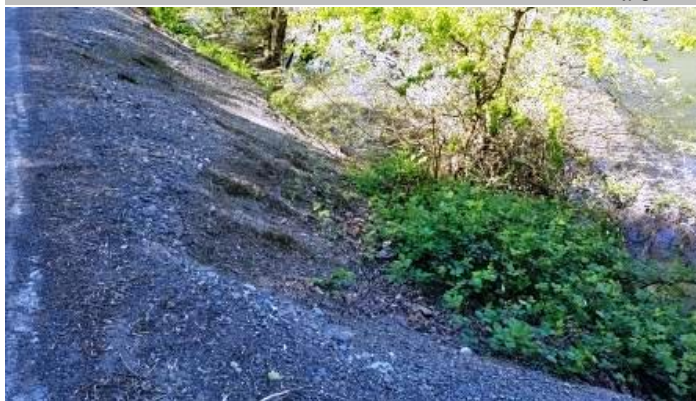
View of erosion on waterside slope. Spring 2019

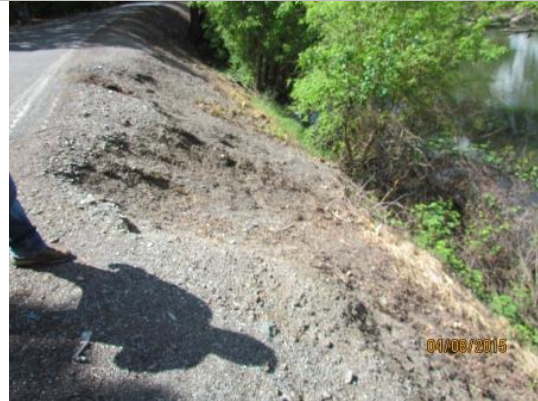
View of erosion on the waterside of the levee during spring 2015 inspection.

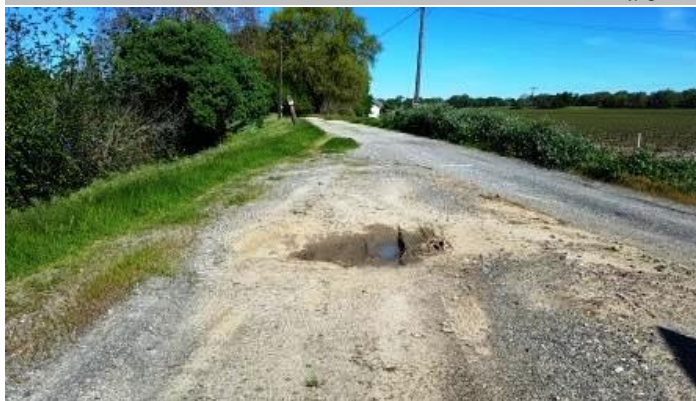
View of pothole on levee crown. Spring 2019

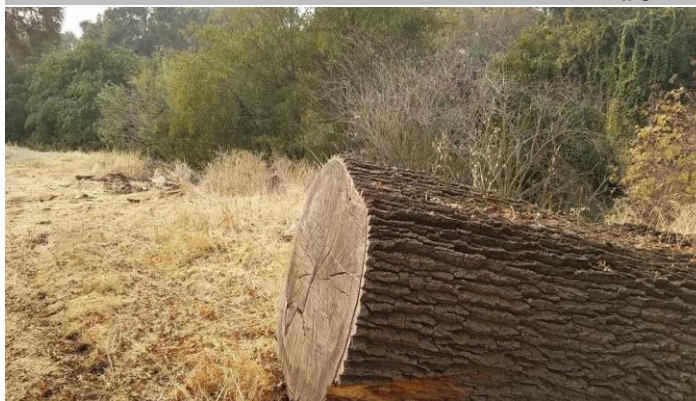
View of tree log on levee slope. Fall 2018

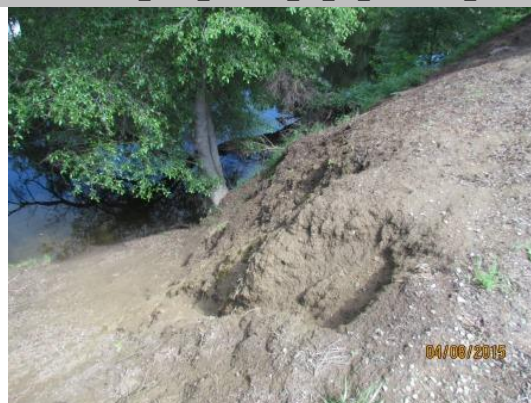
View of slope instability on the waterside of the levee looking upstream during spring 2015 inspection.

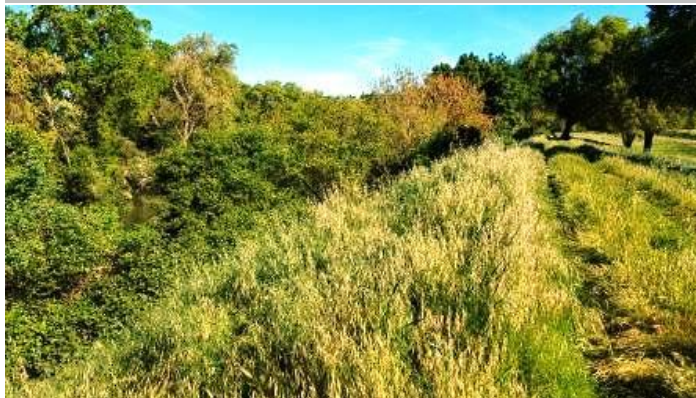
View of tall waterside vegetation. Spring 2019

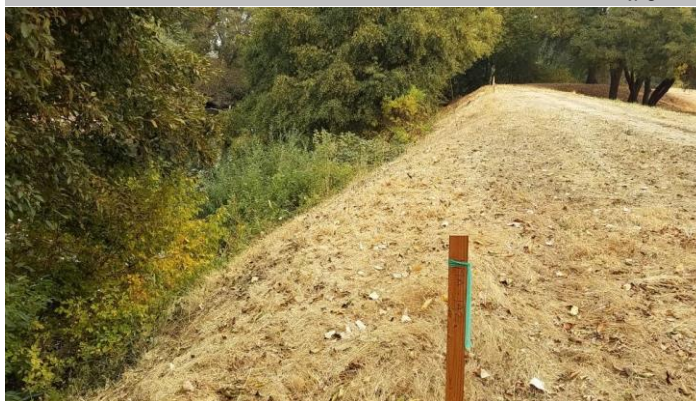
View of waterside slope. Fall 2018

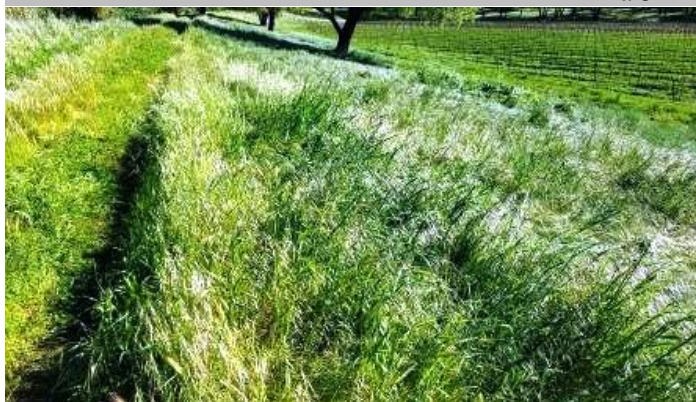
View of tall landside vegetation. Spring 2019

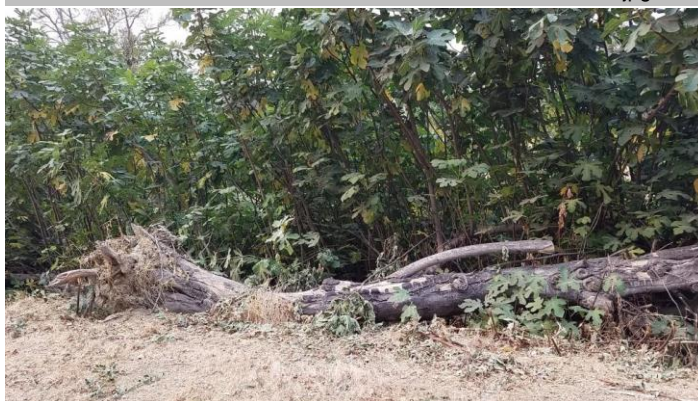
View of fallen tree on levee slope. Fall 2018
